The replacement of the brake pedal spring, and it's bushings is not a Winter project, but you must not imagine it can be done in fifteen minutes. Another option would be to do the repair the following way.

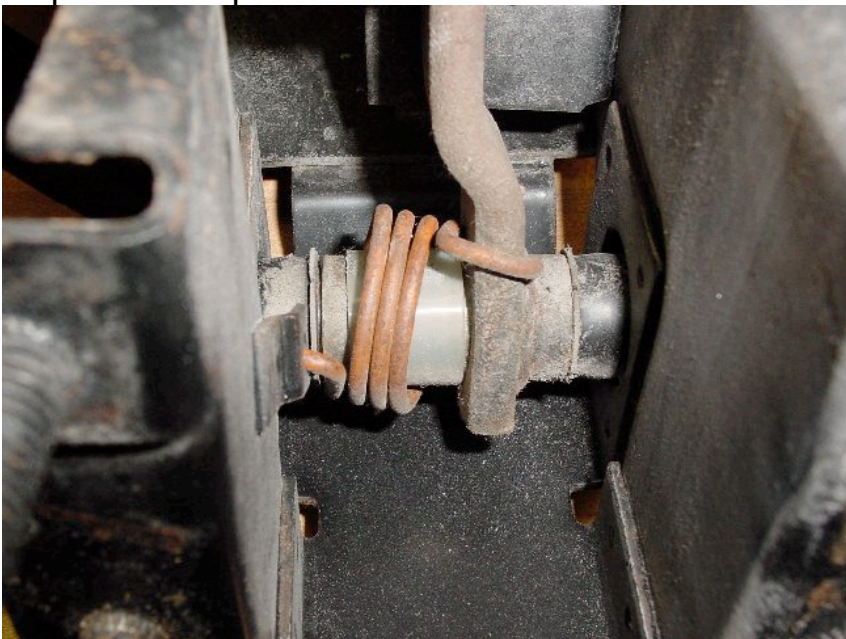
The correct method is to first remove the brake pedal clevis pin spring retainer. Then slip the pin out of the pedal, and gentle push the clevis to the side. Next, remove the pivot shaft spring clip (it's a little higher) that locks the pivot shaft in place. Then remove the clutch rod spring retainer, and remove the clutch rod from the clutch pedal and let it drop down.

Once all this is completed, all that you need to do is to gentle pull the clutch pedal to towards the left side of the car, and the brake pedal will fall into your hands. The broken brake pedal spring can then be replaced, along with the pedal bushings. Then lube with a little white grease, and reverse the procedure to re-assemble the pedals.
